Memorandum

Source Control Decision

Owens Corning - Linnton Roofing and Asphalt Facility

ECSI # 1036

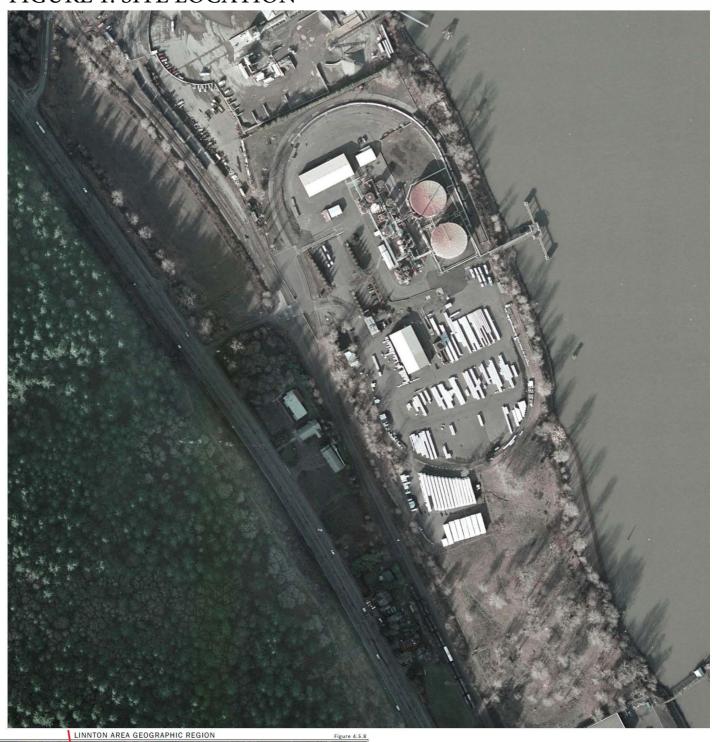
FIGURE 1: SITE LOCATION

The OC – Linnton site covers approximately 44.3 acres bordering the west bank of Willamette River at approximately river mile 3.5, as shown in Figure 1. Topography is relatively flat. A functional dock provides river access, though it is currently not used for business at the site.
